# Oak Meyer Gardens HOA

Monuments and Markers  
PIAC Proposal

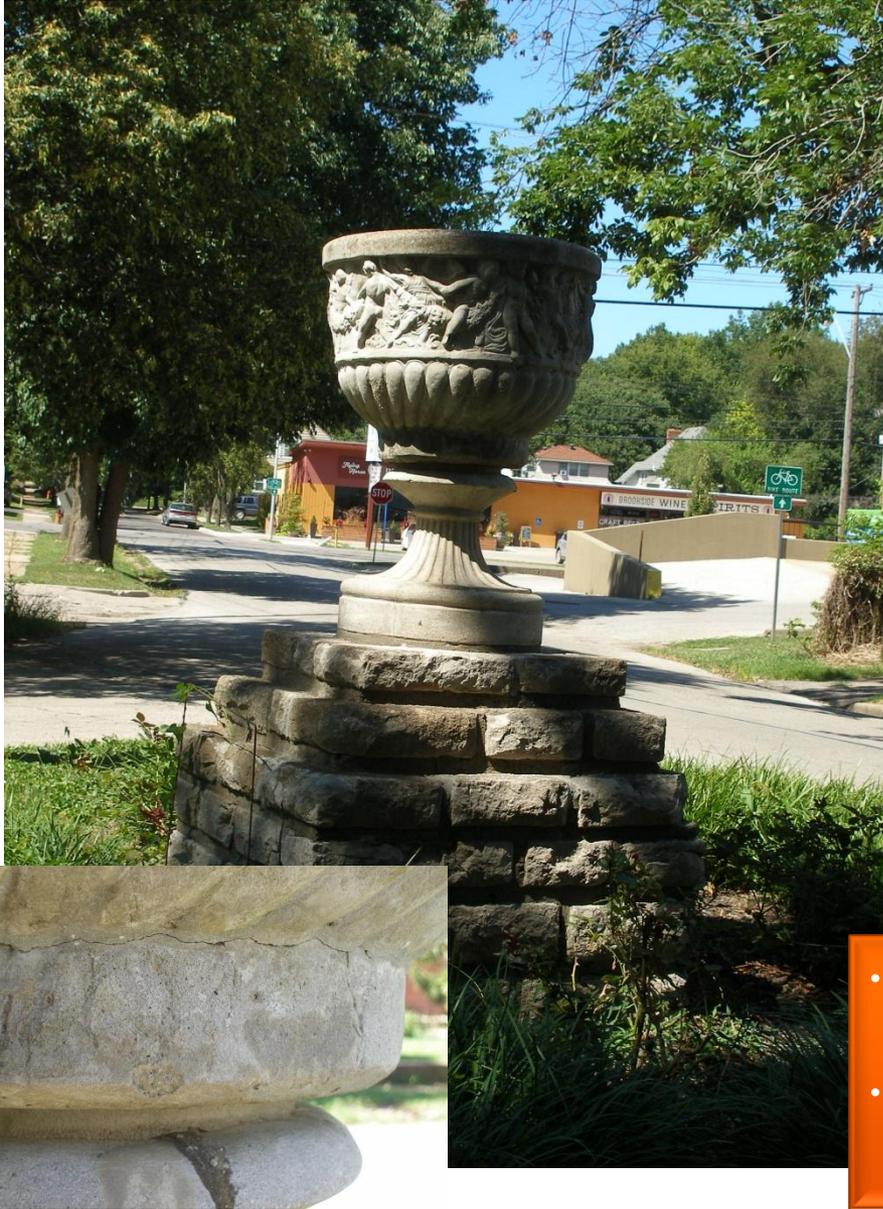
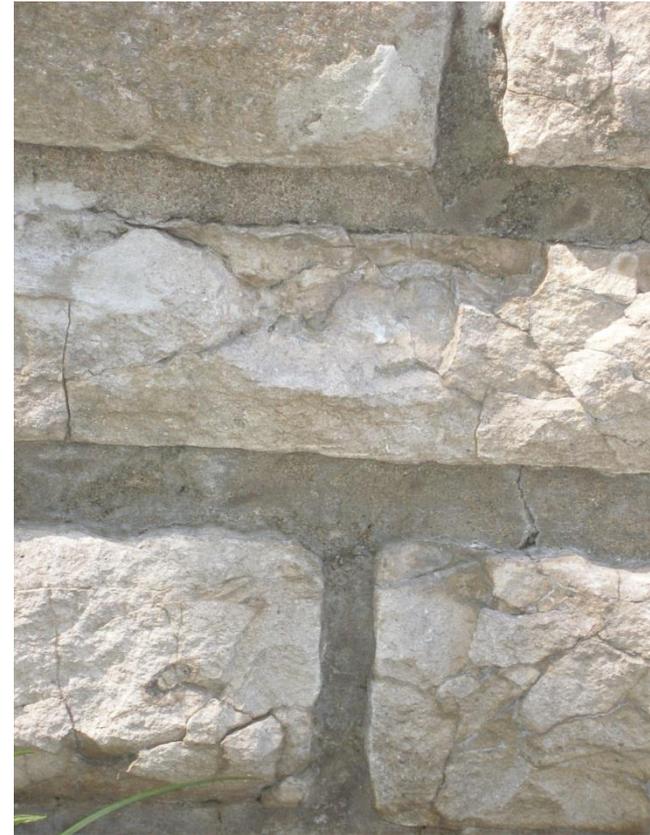
- Stone is cracked from age and weather. Many stones need to be replaced.
- Vase base is broken and needs to be repaired.

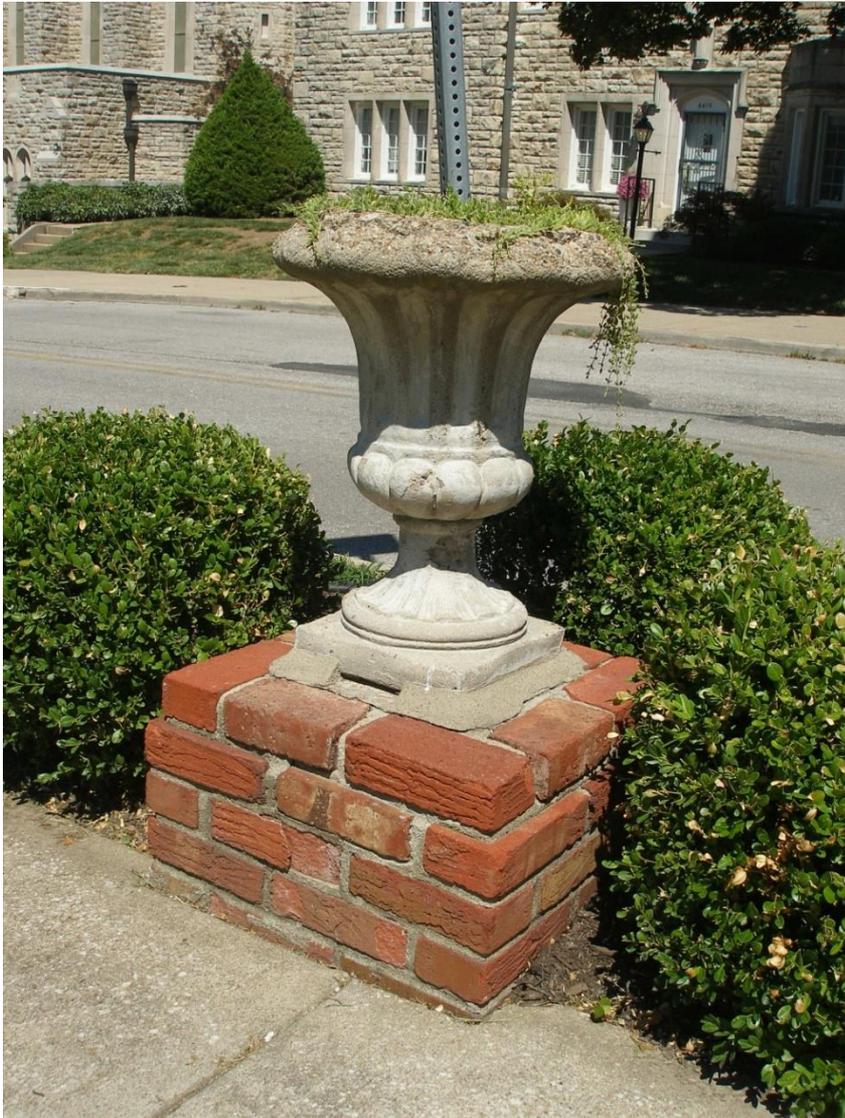
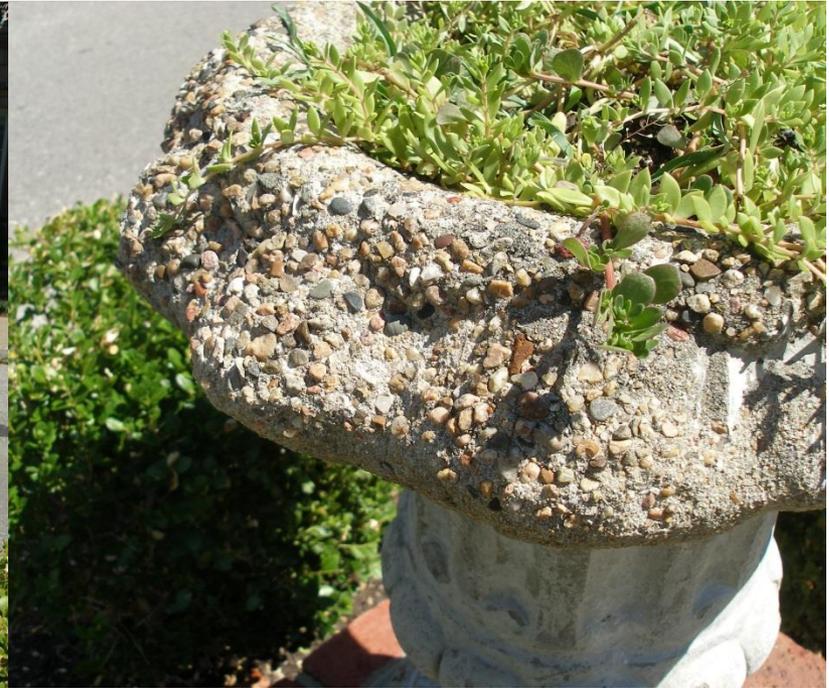
- This is the only brick pedestal pair in the neighborhood and is likely a replacement. It should be rebuilt with stone.
- The vase is worn beyond repair and needs to be replaced.
- A limestone cap to protect new stonework from the weather will be added.

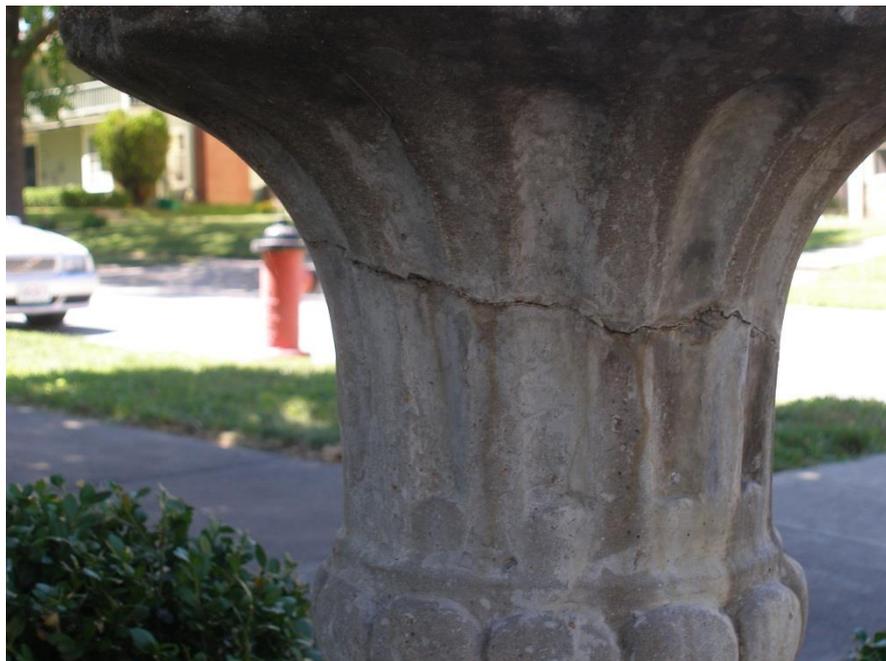
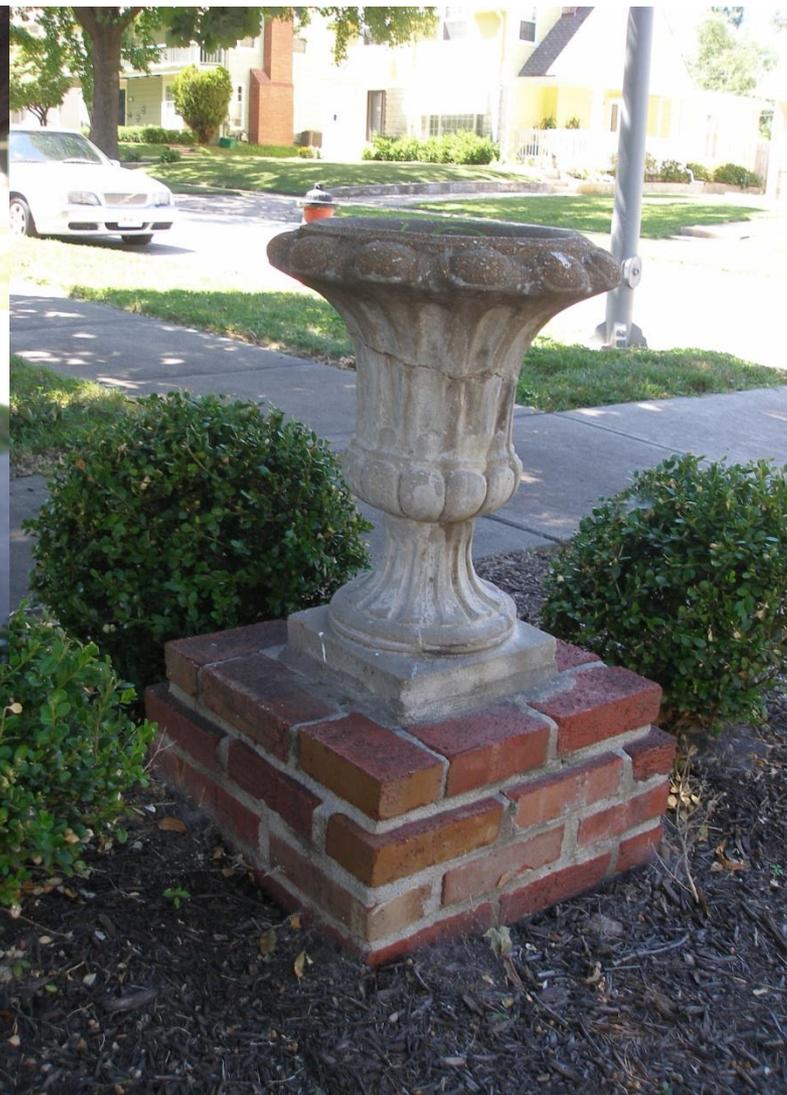
- Will replace brick masonry with stone to match the neighborhood.
- Vase is worn and damaged beyond repair and needs to be replaced.

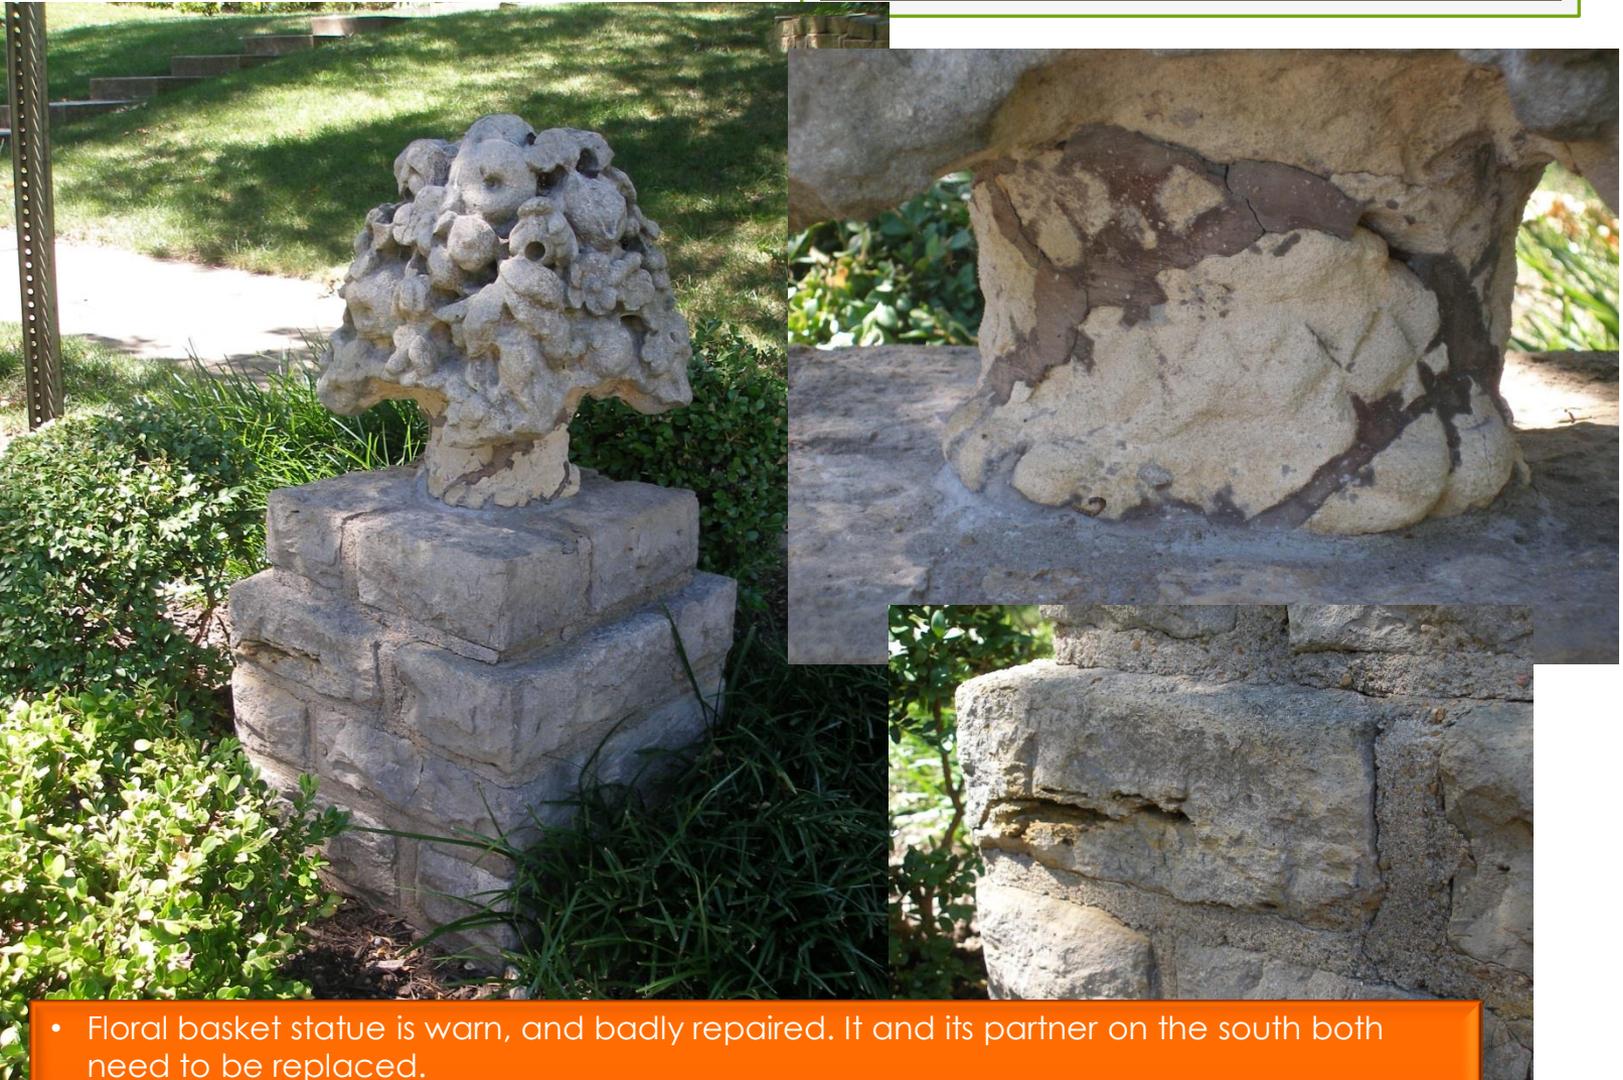
- Floral basket statue is worn, and badly repaired. It and its partner on the south both need to be replaced.
- Both stone walls have stones that are crumbling and need to be replaced.
- A limestone cap to protect new masonry work for the next 75 years should be added.

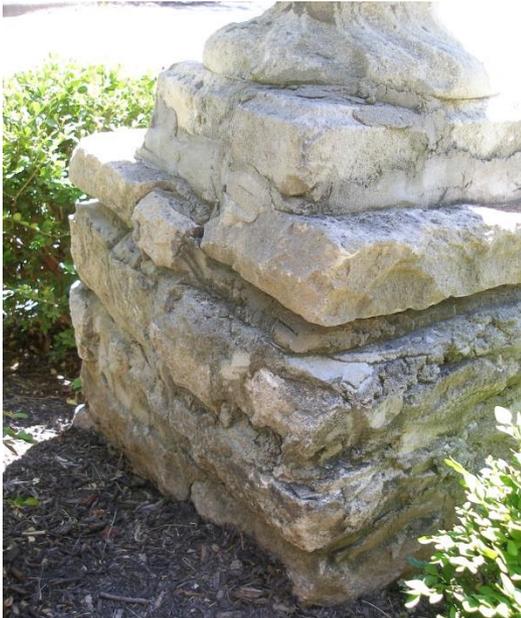
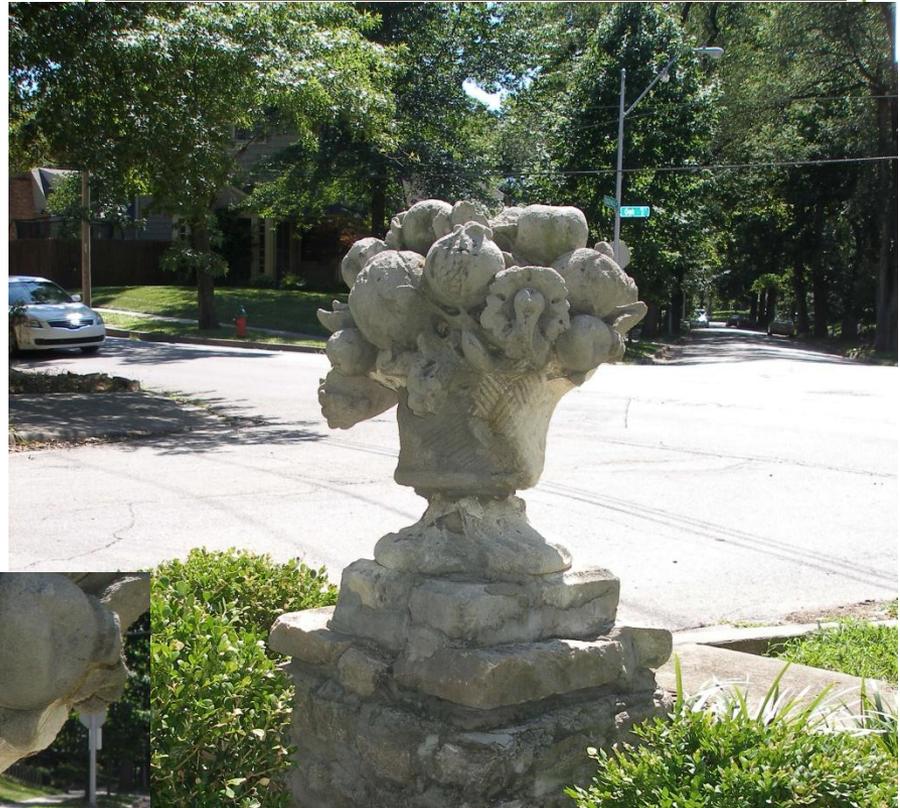
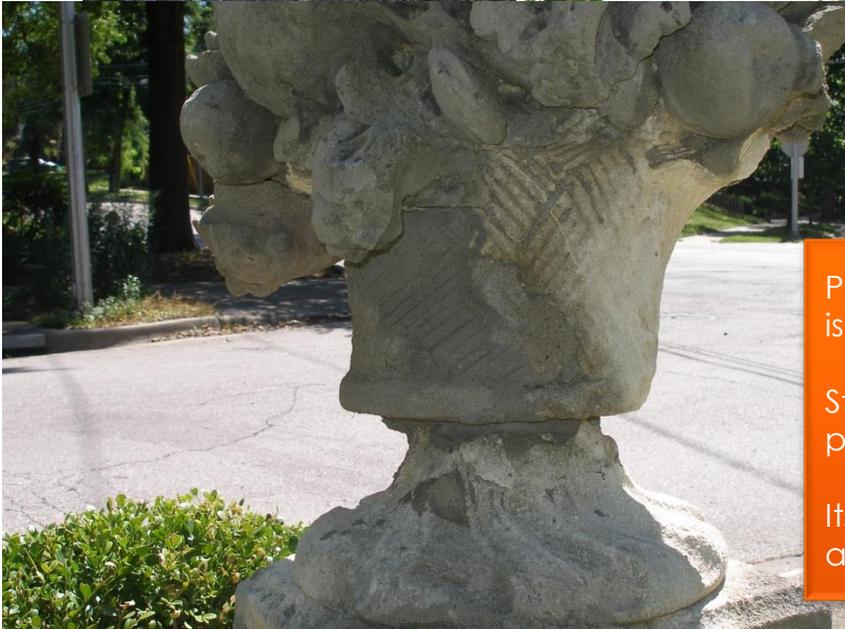
Pedestal needs to be completely replaced – is collapsing.

Stone basket is damaged and badly patched. Needs to be replaced as well.

Its partner on the south is in similar condition and requires similar treatment.

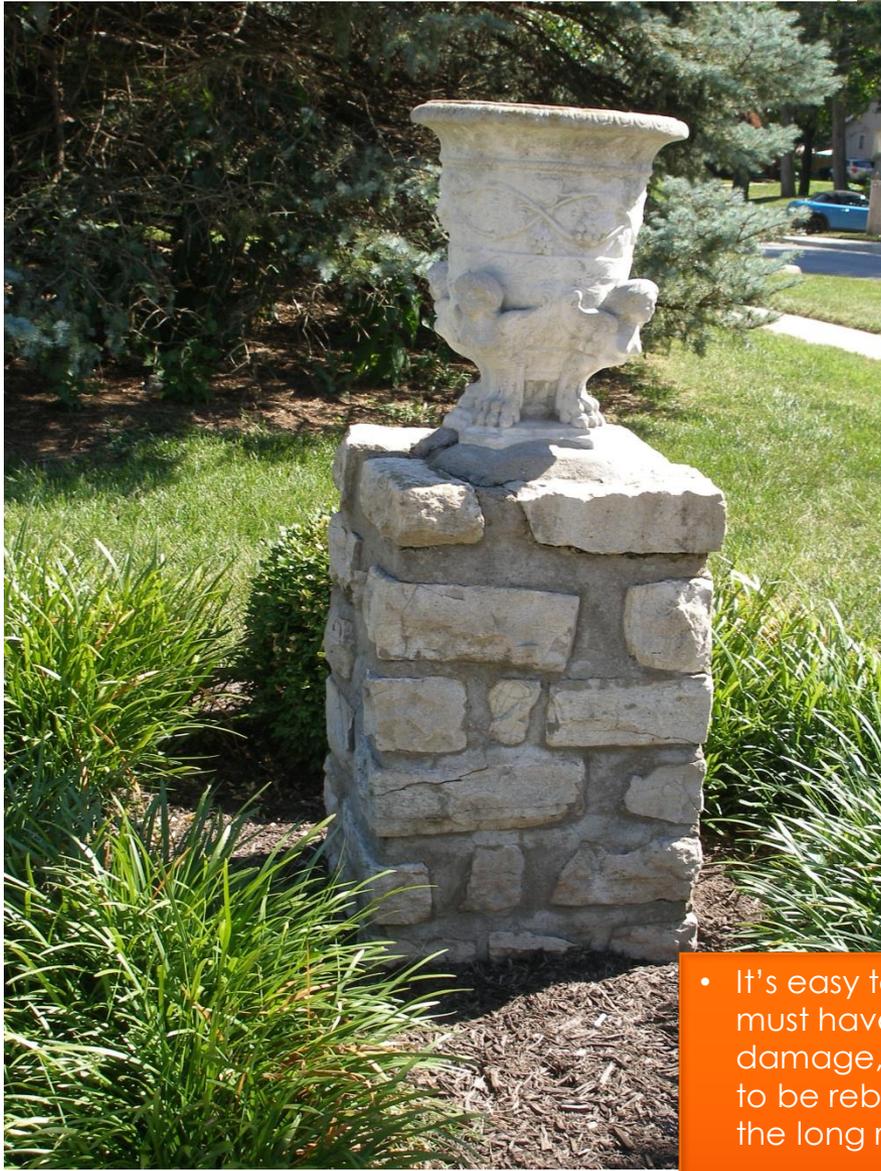
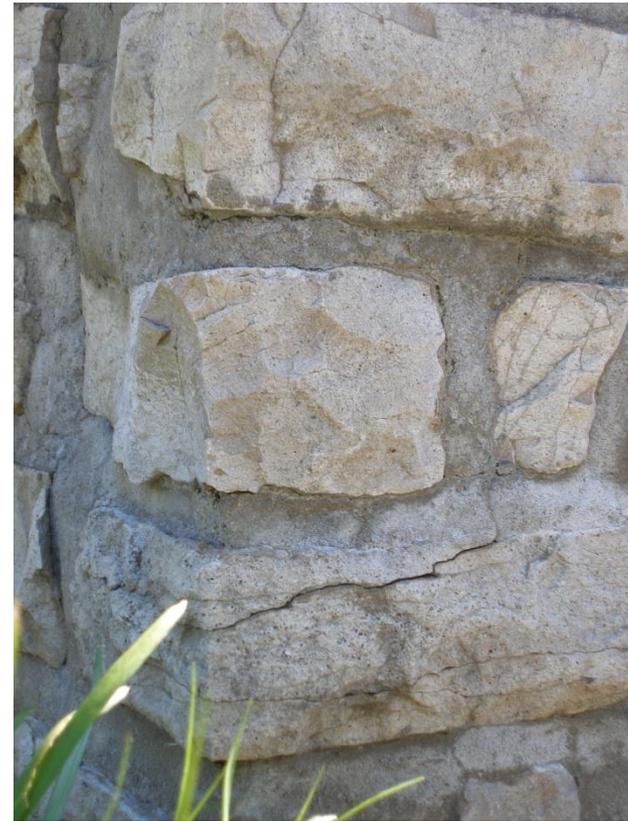
- It's easy to see what is wrong here. The pedestal must have been rebuilt by an amateur after damage, perhaps by a vehicle. This pedestal needs to be rebuilt and capped to protect the masonry for the long run.
- Unfortunately, many of the stones are cracked and need to be replaced as well.

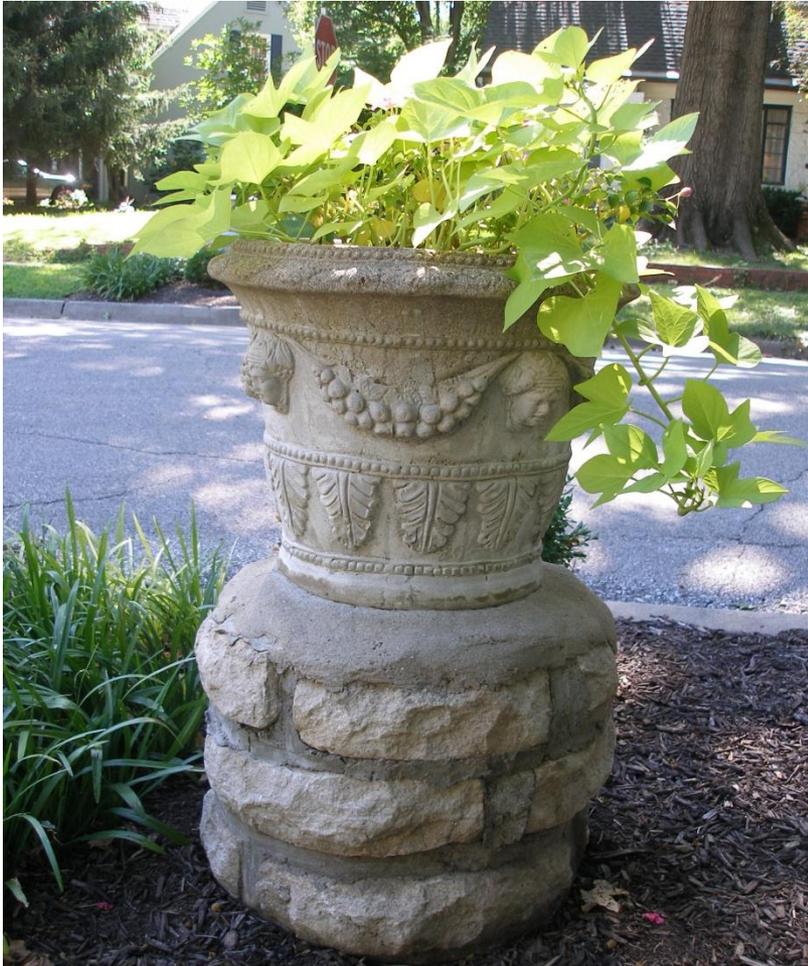
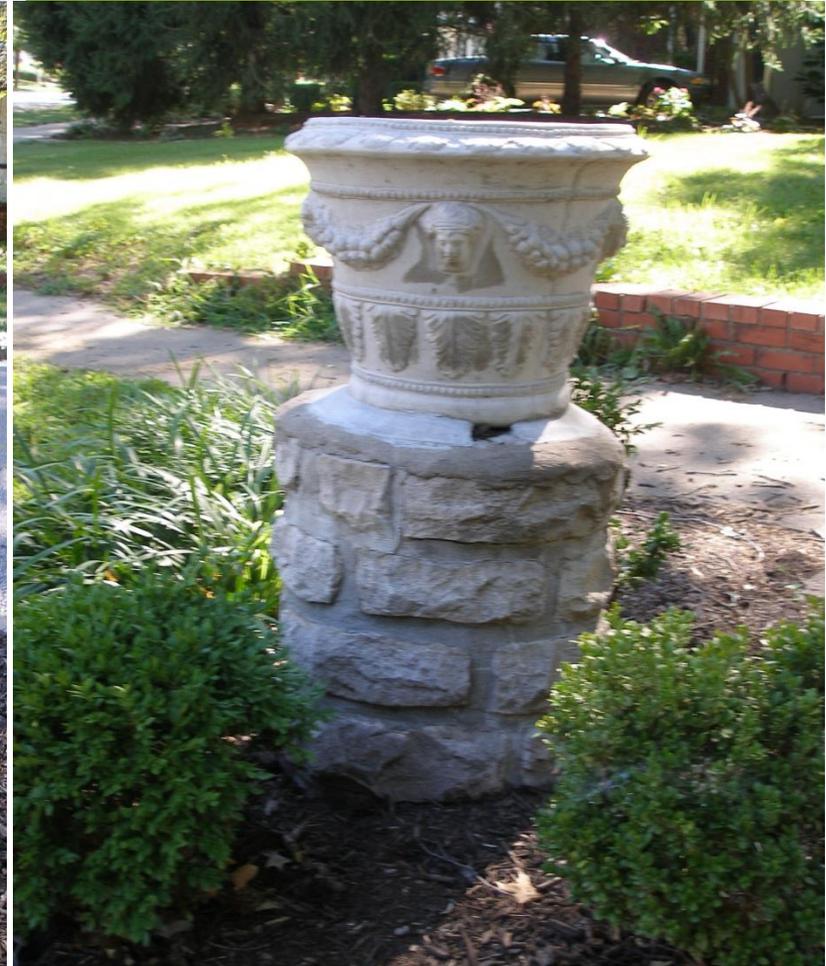
- One of these pedestals must have been rebuilt at one time, and does not match the other in size.
- It is necessary to rebuild both pedestals with ones sized more proportionately to properly fit their vases.
- Again, limestone caps would be added to protect the masonry for many years to come.

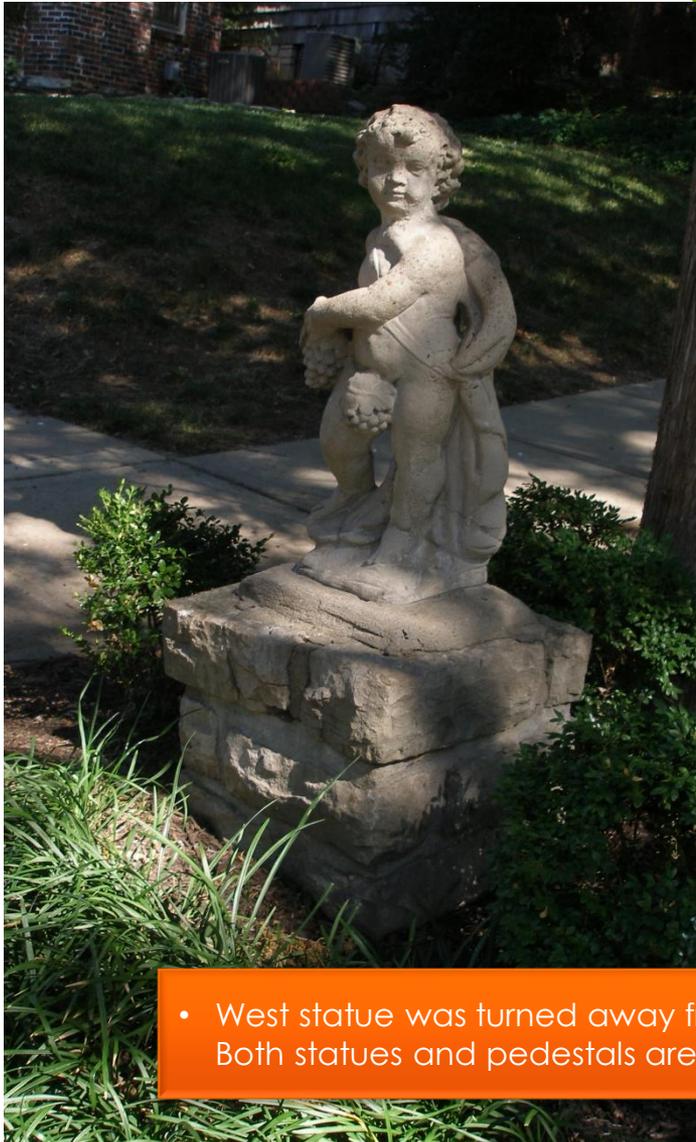
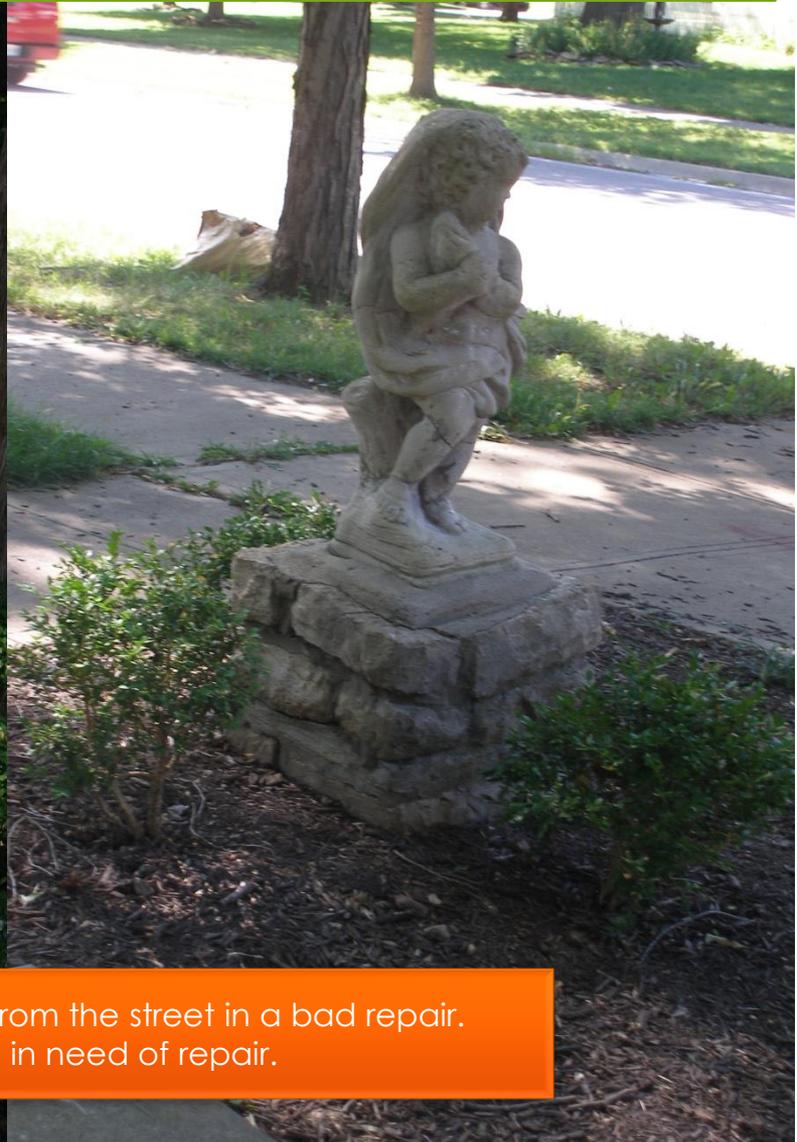
- West statue was turned away from the street in a bad repair. Both statues and pedestals are in need of repair.

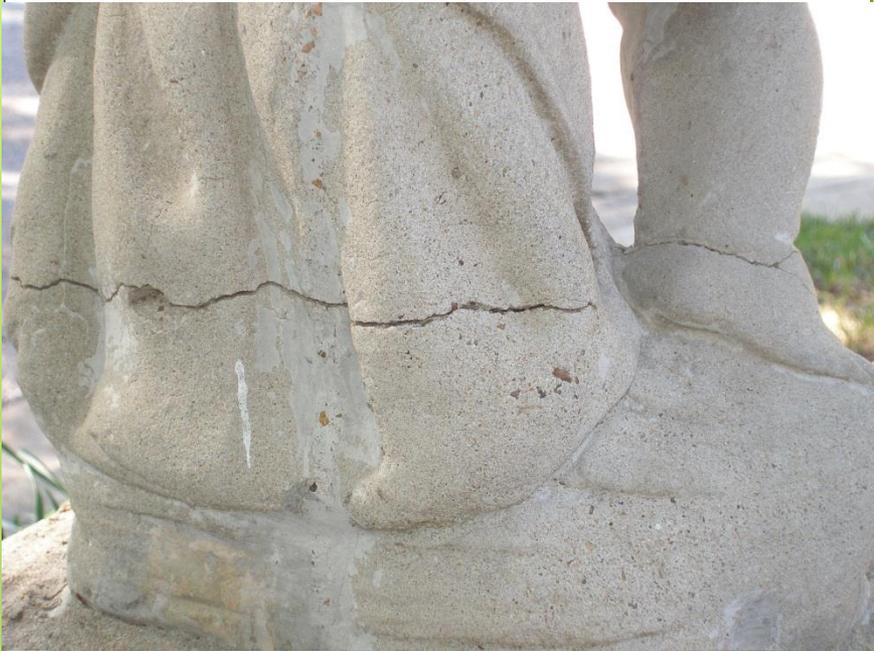
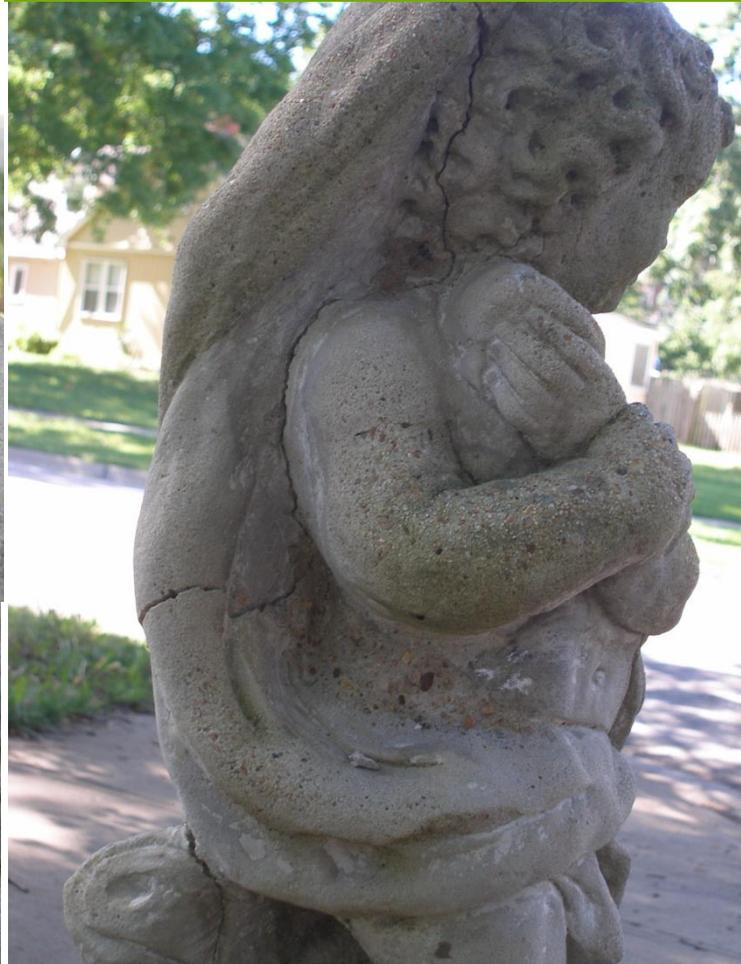
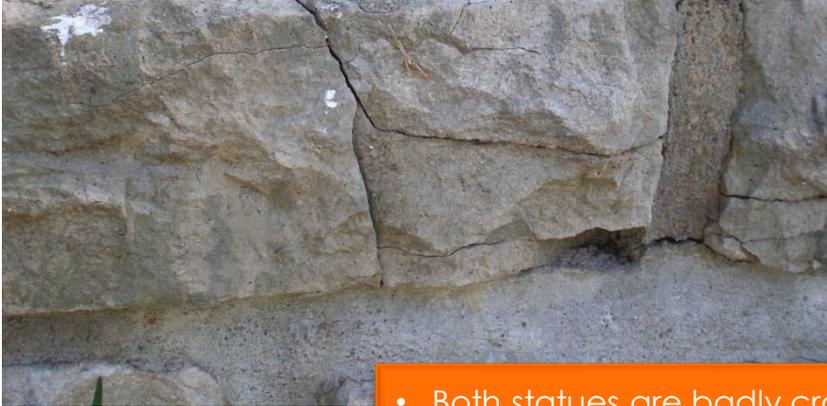
- Both statues are badly cracked, but we hope to salvage one and replace the other one with a statue from a different location.
- The pedestals are in bad shape. It is more cost effective to replace them than repair them due to their smaller size.

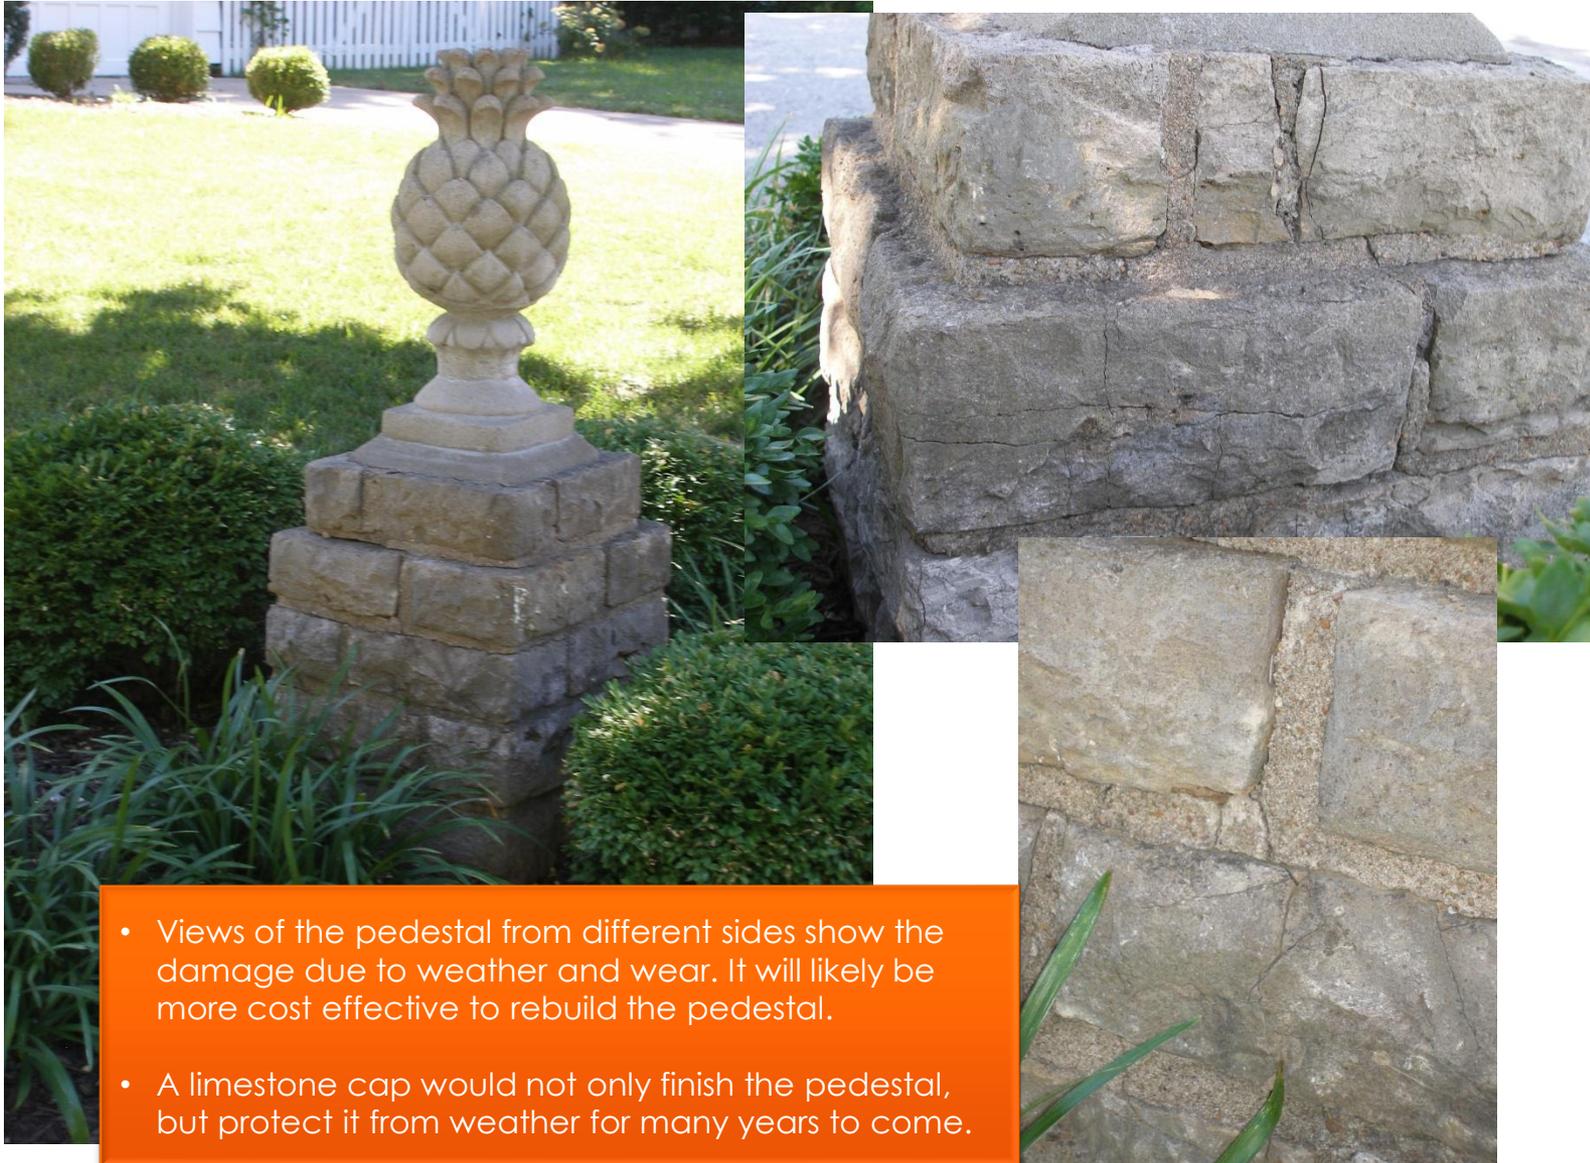
- Views of the pedestal from different sides show the damage due to weather and wear. It will likely be more cost effective to rebuild the pedestal.
- A limestone cap would not only finish the pedestal, but protect it from weather for many years to come.

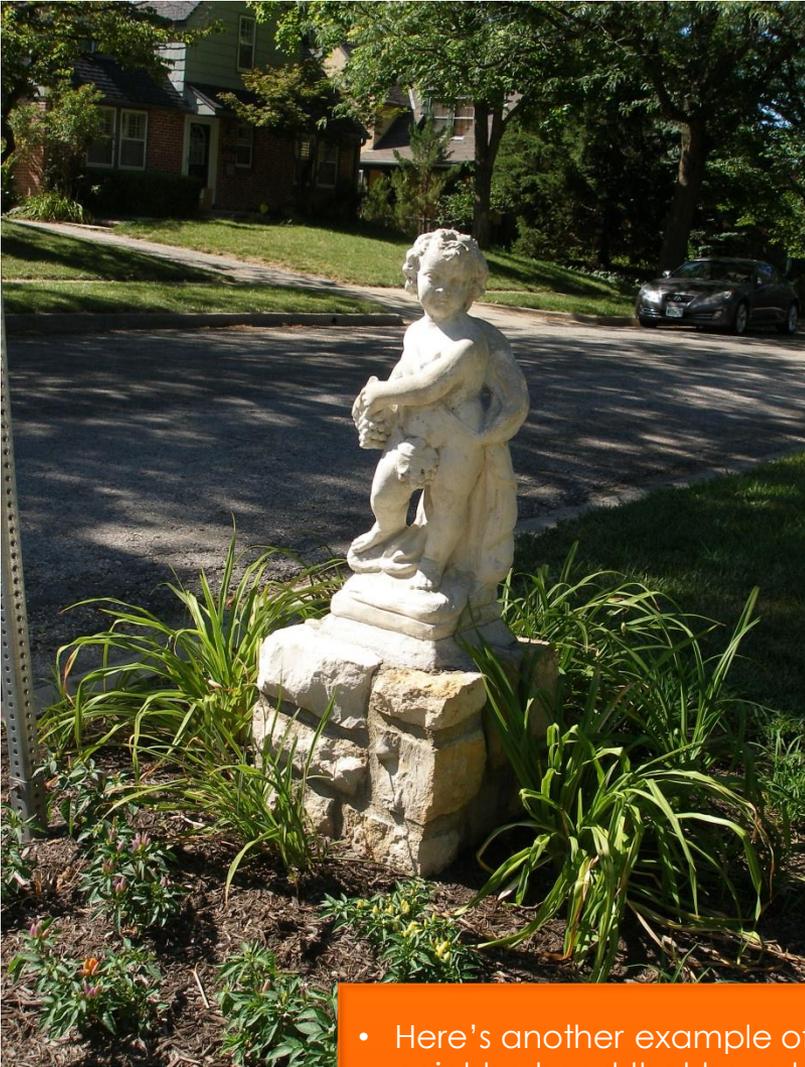
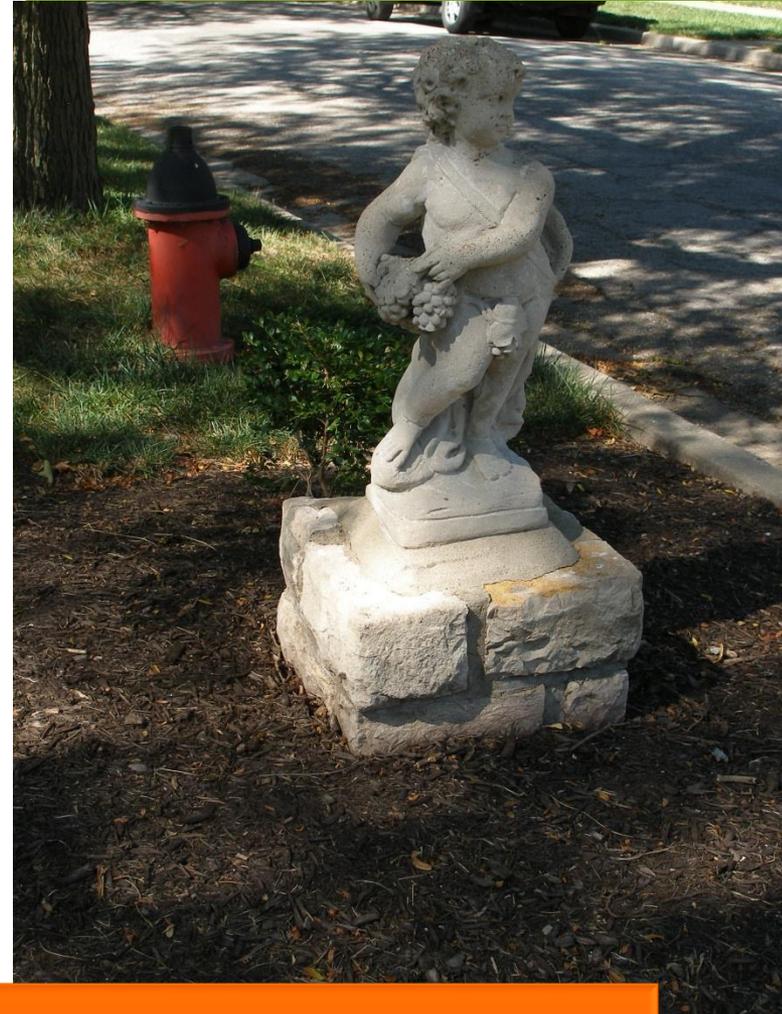
- Here's another example of many pedestals pairs throughout the neighborhood that have been re built to different levels in older repairs. We would like to replace both pedestals for ones that are more proportionate to the size of the statues and give them limestone caps.

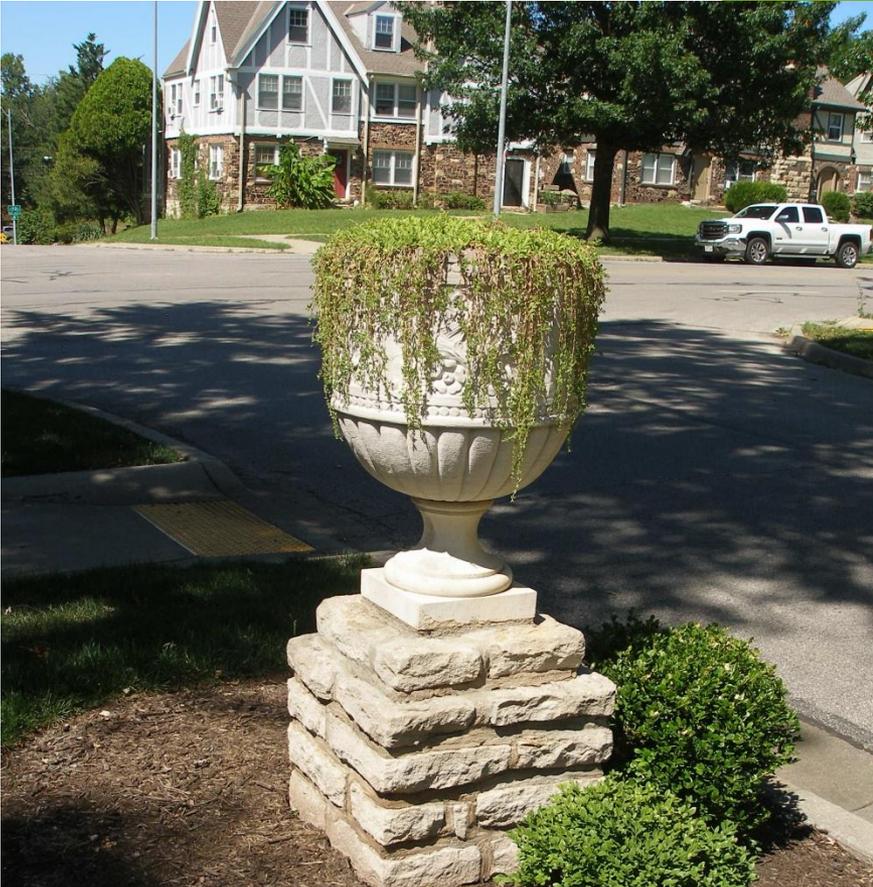
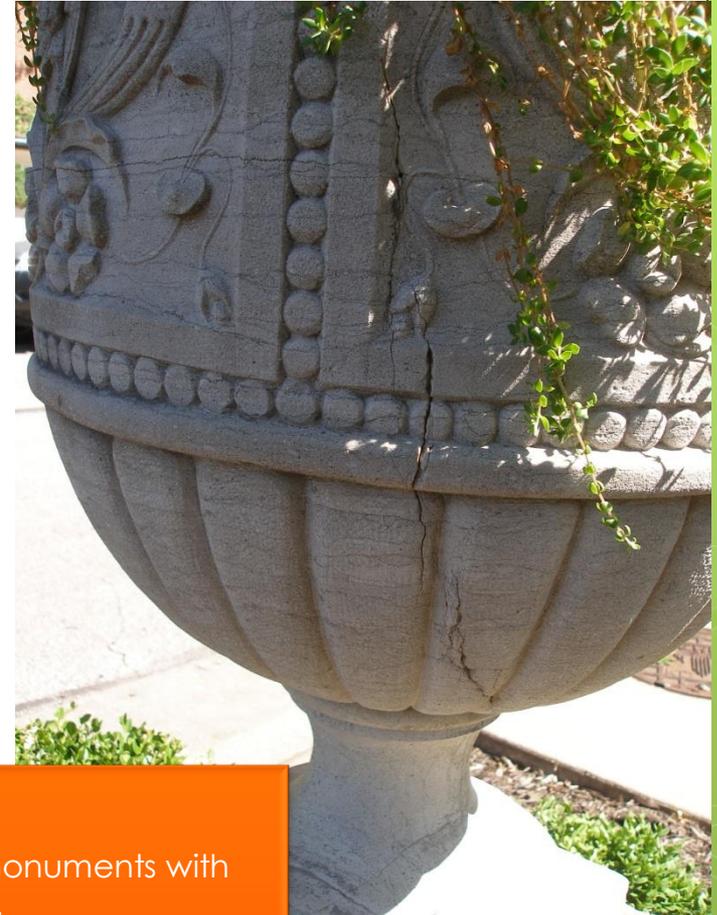
- The pedestals at Cherry and Meyer Boulevard are highly visual monuments with lovely, large vases. The vases are cracked and in need of repair.
- The pedestal stones are worn,. Cracked stones need to be replaced and tuck pointing provided.
